Owasco Lake Watershed 2015 Roadside Ditch Assessment

Owasco Lake Watershed Inspection Program
7413 County House Road Auburn, NY 13021

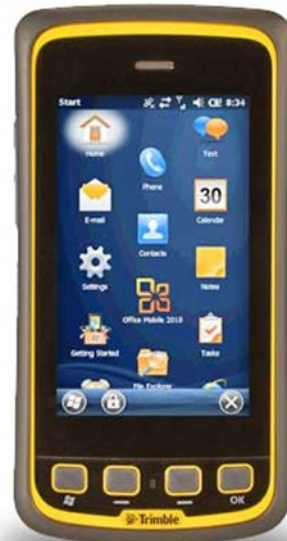
A Trimble GPS unit is used to map different features of the ditches allowing for the Inspection Program to categorize the level of erodibility and risk of ditch failure

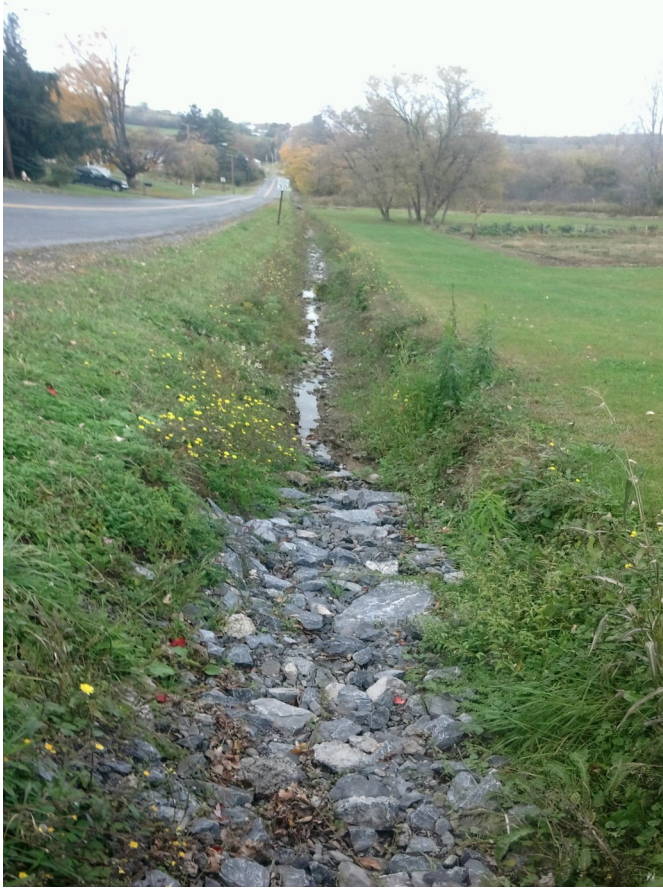
Map Identification	Site 1
Road Name	North Rd
Town	Owasco
Length of Ditch	1122 ft
Height/Width of Ditch	4-6 ft/3-4 ft
Percent Vegetation	15%
Ground Type	Soil
Current Condition	Continuous Erosion
Sub-Watershed	Dutch Hollow
Road Jurisdiction	County
Closest Intersection	Rt 38A
Rank	Moderate

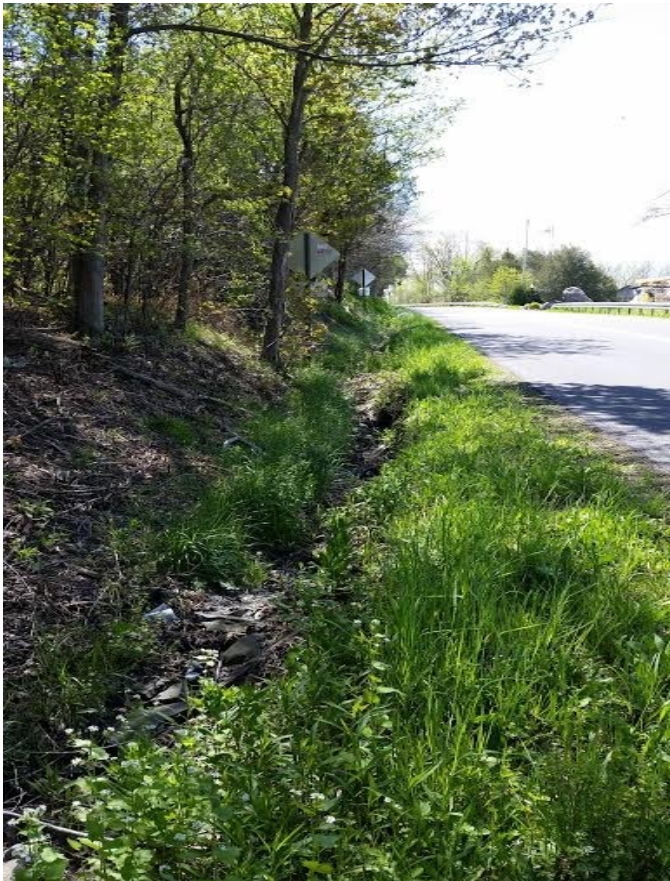
Map Identification	Site 2
Road Name	Rockefeller Rd
Town	Niles
Length of Ditch	3787 ft
Height/Width of Ditch	2-3 ft/3-4 ft
Percent Vegetation	20%
Ground Type	Soil/Gravel
Current Condition	Continuous Erosion
Sub-Watershed	Direct Drainage
Road Jurisdiction	County
Closest Intersection	Firelane 16A
Rank	Moderate

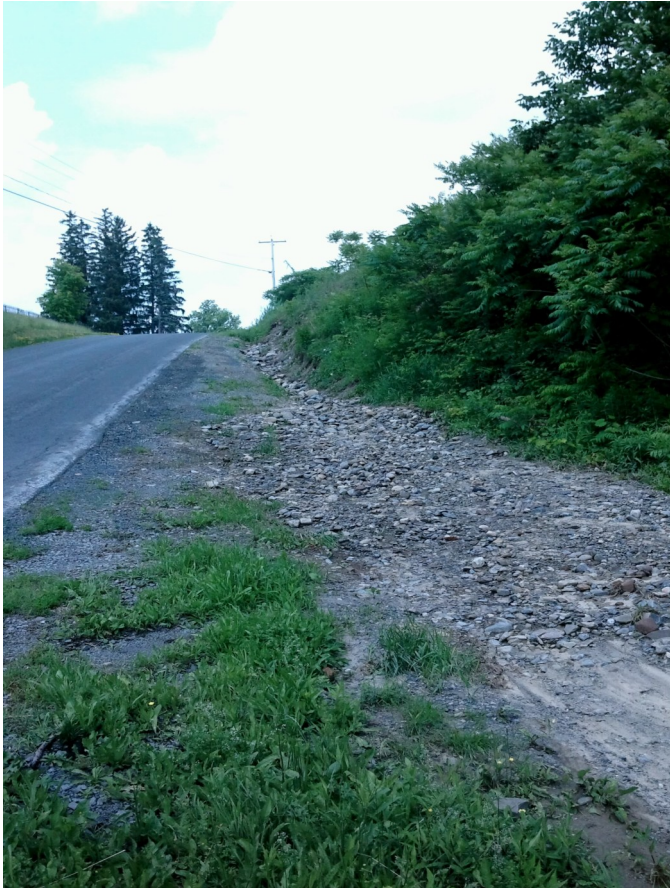
Map Identification	Site 3
Road Name	Cemetery Rd
Town	Skaneateles
Length of Ditch	251 ft
Height/Width of Ditch	4-6 ft/3-4 ft
Percent Vegetation	30%
Ground Type	Gravel
Current Condition	Continuous Erosion
Sub-Watershed	Dutch Hollow
Road Jurisdiction	County
Closest Intersection	Twelve Corners
Rank	High

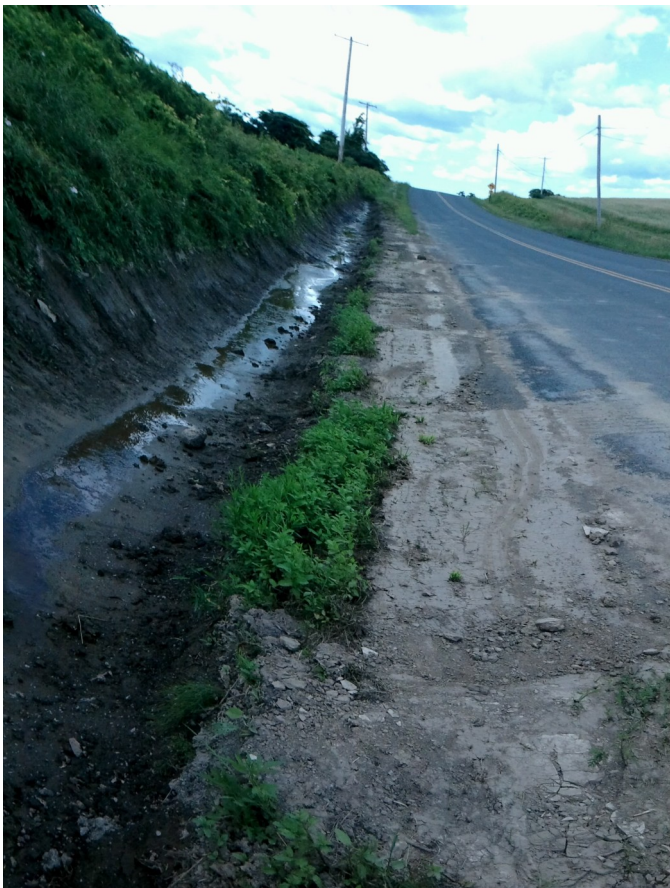
Map Identification	Site 4
Road Name	Twelve Corners
Town	Niles
Length of Ditch	265 ft
Height/Width of Ditch	3-4 ft/6-8 ft
Percent Vegetation	0%
Ground Type	Soil/Gravel
Current Condition	Continuous Erosion
Sub-Watershed	Dutch Hollow
Road Jurisdiction	County
Closest Intersection	Fitzpatrick Rd
Rank	High

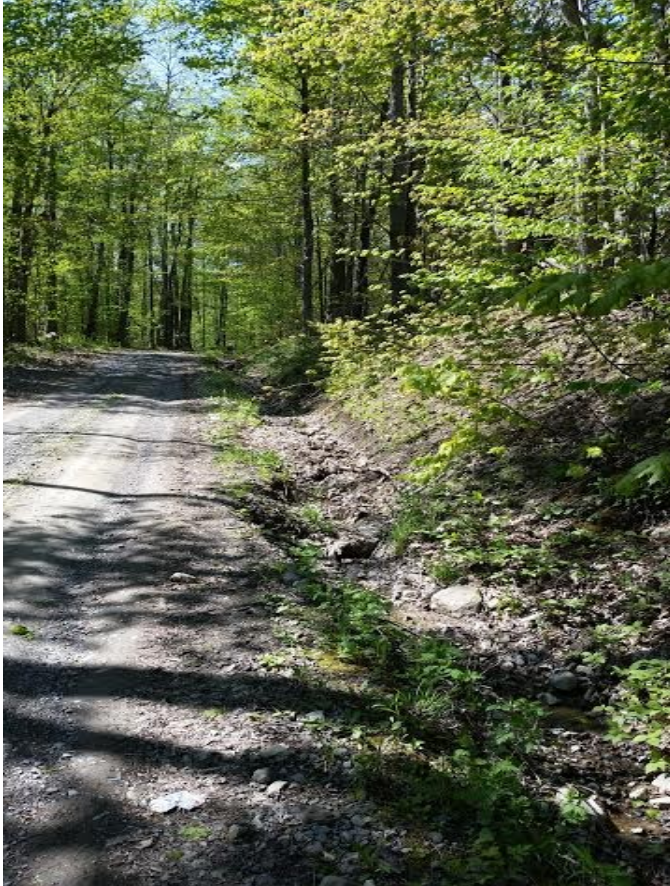
Map Identification	Site 5
Road Name	Fitzpatrick Rd
Town	Niles
Length of Ditch	3336 ft
Height/Width of Ditch	4-6 ft/3-5ft
Percent Vegetation	15%
Ground Type	Gravel
Current Condition	Continuous Erosion
Sub-Watershed	Dutch Hollow
Road Jurisdiction	County
Closest Intersection	Twelve Corners
Rank	High

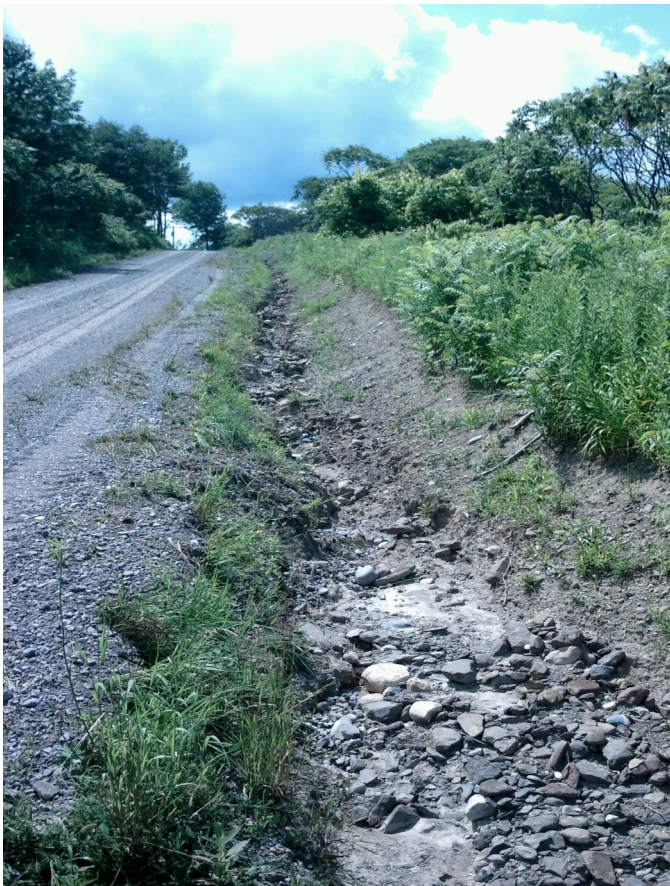
Map Identification	Site 6
Road Name	Richardson Rd
Town	Niles
Length of Ditch	2012 ft
Height/Width of Ditch	2-3 ft/2-4 ft
Percent Vegetation	0%
Ground Type	Gravel
Current Condition	Continuous Erosion
Sub-Watershed	Dutch Hollow
Road Jurisdiction	Local
Closest Intersection	Old State Rd
Rank	High

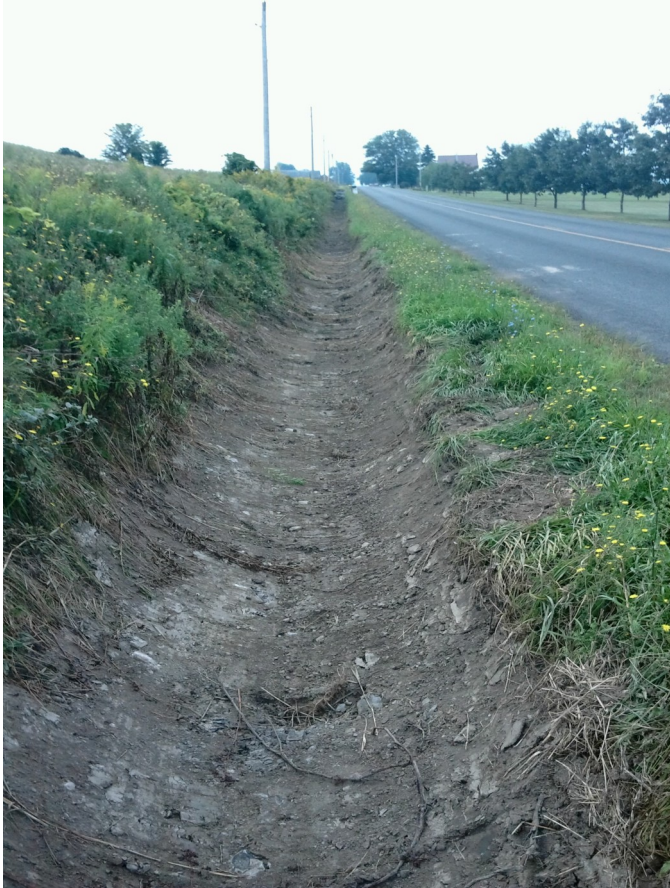
Map Identification	Site 7
Road Name	Rockefeller Rd
Town	Niles
Length of Ditch	1821 ft
Height/Width of Ditch	3-4 ft/4-5 ft
Percent Vegetation	0%
Ground Type	soil
Current Condition	Continuous Erosion
Sub-Watershed	Direct Drainage
Road Jurisdiction	County
Closest Intersection	Arnold Rd
Rank	Moderate

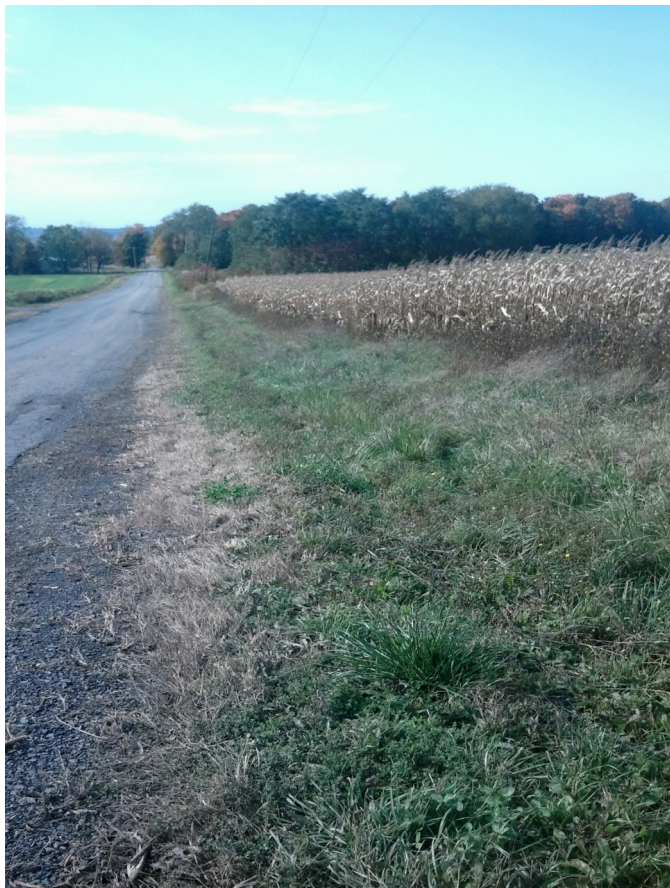
Map Identification	Site 8
Road Name	Grange Hall Rd
Town	Niles
Length of Ditch	2356 ft
Height/Width of Ditch	2-3 ft/3-4 ft
Percent Vegetation	80%
Ground Type	Soil/Grass
Current Condition	Slight Erosion
Sub-Watershed	Direct Drainage
Road Jurisdiction	County
Closest Intersection	Gahwiler Rd
Rank	Low

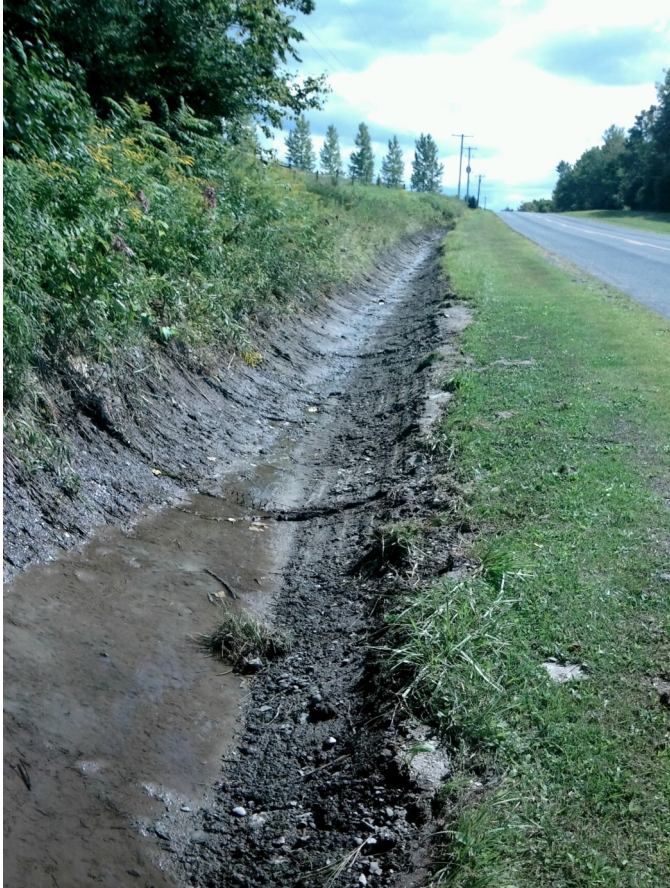
Map Identification	Site 9
Road Name	Oak Hill Rd
Town	Niles
Length of Ditch	1000 ft
Height/Width of Ditch	2-3ft/3-4 ft
Percent Vegetation	0%
Ground Type	Soil
Current Condition	Continuous Erosion
Sub-Watershed	Direct Drainage
Road Jurisdiction	County
Closest Intersection	Quarry Rd
Rank	Moderate

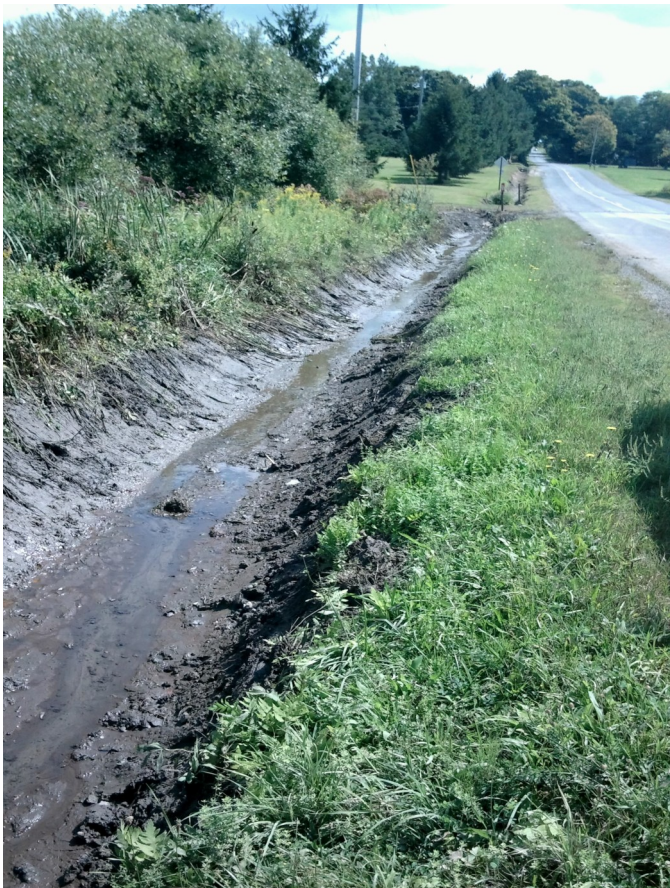
Map Identification	Site 10
Road Name	Oak Hill Rd
Town	Niles
Length of Ditch	488 ft
Height/Width of Ditch	2-3 ft/3-4 ft
Percent Vegetation	0%
Ground Type	Soil
Current Condition	Continuous Erosion
Sub-Watershed	Direct Drainage
Road Jurisdiction	County
Closest Intersection	Quarry Rd
Rank	Moderate

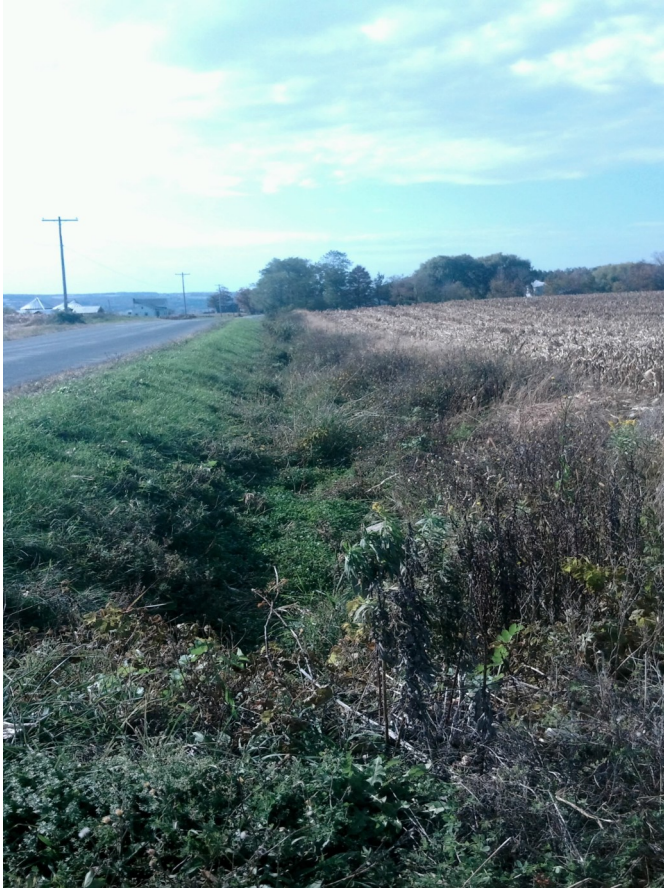
Map Identification	Site 11
Road Name	Duryea St.
Town	Niles
Length of Ditch	1757 ft
Height/Width of Ditch	3-4 ft/5-6 ft
Percent Vegetation	30%
Ground Type	Soil/Gravel
Current Condition	Continuous Erosion
Sub-Watershed	Direct Drainage
Road Jurisdiction	County
Closest Intersection	Oak Hill Rd
Rank	High

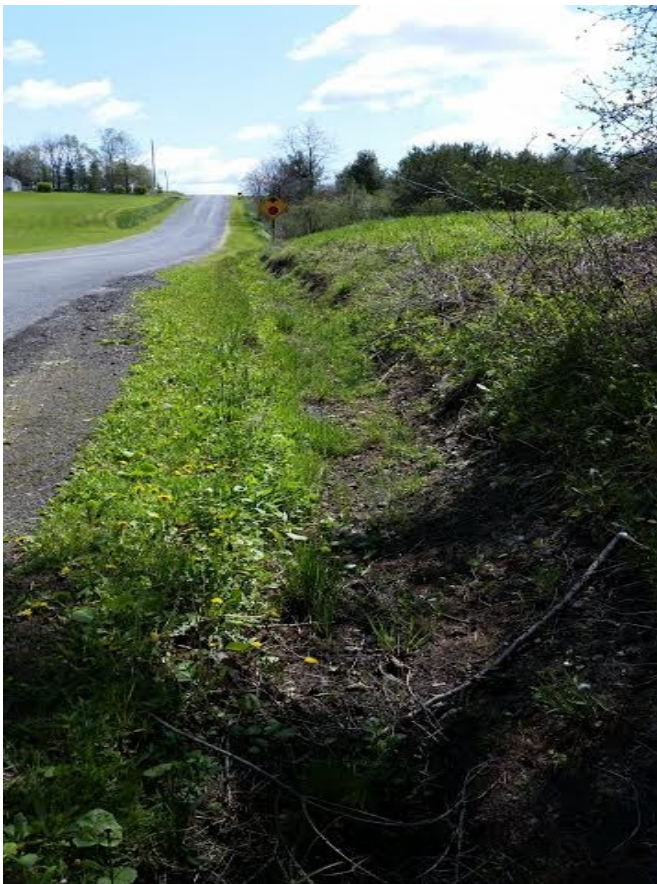
Map Identification	Site 12
Road Name	Jugg Street
Town	Moravia
Length of Ditch	385 ft
Height/Width of Ditch	2-3 ft/4-5 ft
Percent Vegetation	15%
Ground Type	Woody
Current Condition	Continuous Erosion
Sub-Watershed	Direct Drainage
Road Jurisdiction	County
Closest Intersection	Corrigan Rd
Rank	Low

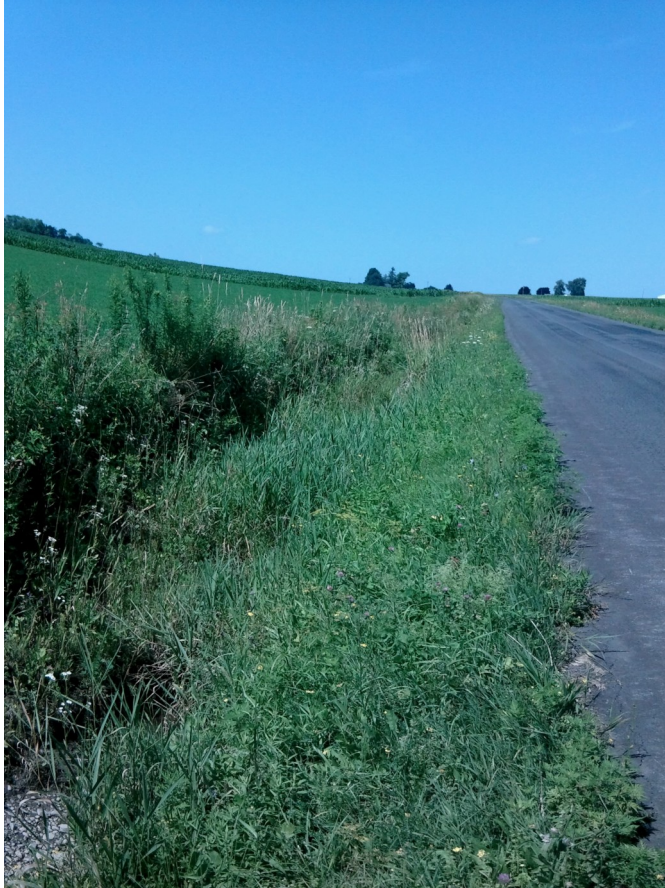
Map Identification	Site 13
Road Name	Hick Rd
Town	Venice
Length of Ditch	1430 ft
Height/Width of Ditch	3-4 ft/4-5 ft
Percent Vegetation	20%
Ground Type	Soil/Grasses
Current Condition	Continuous Erosion
Sub-Watershed	Direct Drainage
Road Jurisdiction	County
Closest Intersection	Wyckoff
Rank	High

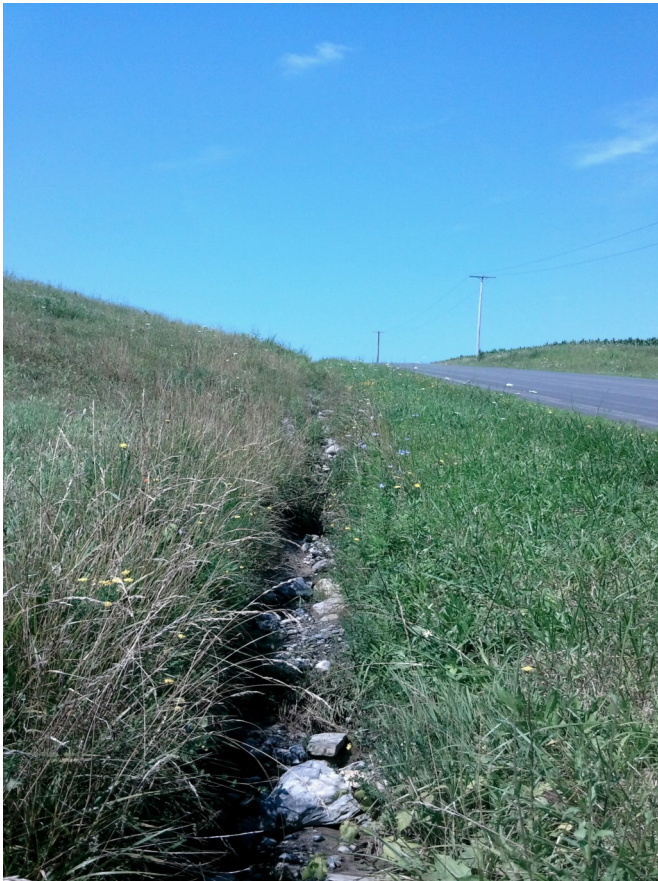
Map Identification	Site 14
Road Name	Center Rd
Town	Venice
Length of Ditch	3534 ft
Height/Width of Ditch	2-3 ft/3-4 ft
Percent Vegetation	15%
Ground Type	Gravel
Current Condition	Continuous Erosion
Sub-Watershed	Direct Drainage
Road Jurisdiction	County
Closest Intersection	Wyckoff
Rank	High

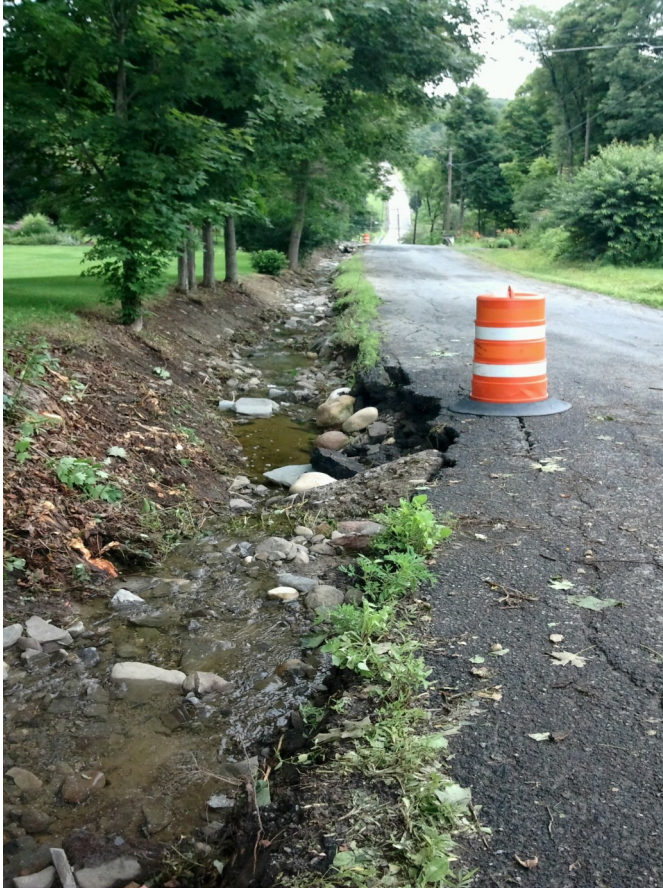
Map Identification	Site 15
Road Name	Sobers Rd
Town	Groton
Length of Ditch	657 ft
Height/Width of Ditch	3-4 ft/6-8 ft
Percent Vegetation	0%
Ground Type	Soil/Gravel
Current Condition	Continuous Erosion
Sub-Watershed	Owasco Inlet
Road Jurisdiction	County
Closest Intersection	Old Peruville
Rank	High
