## Highlights

## Overview of 2011

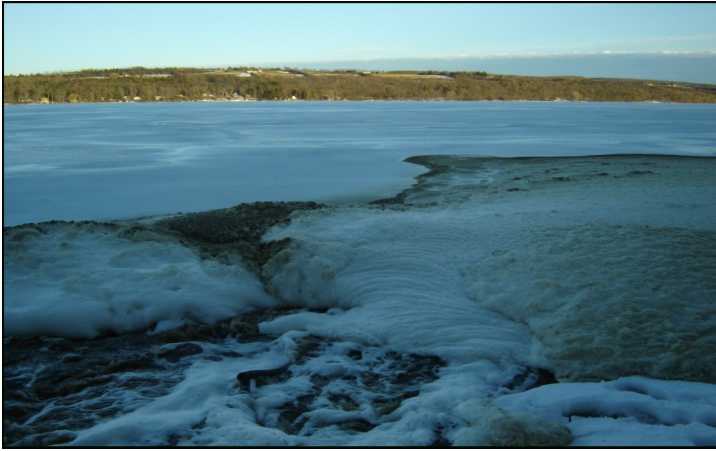
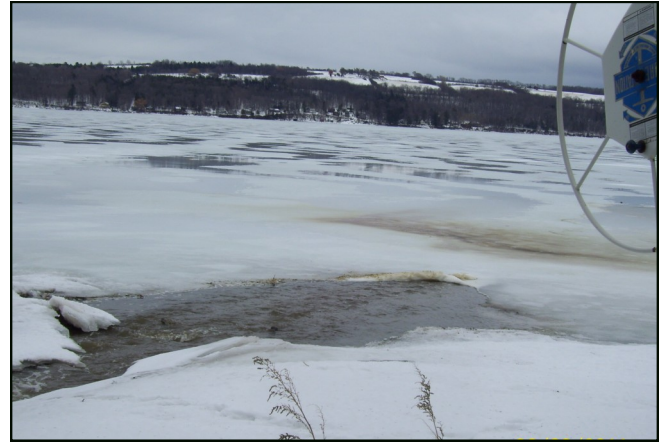
*Above left: A large amount of foam was spotted exiting a feeder stream to the lake indicating excessive loading of nutrients. A follow up inspection to the mouth of the stream 10 days after the incident shows persisting residue (above right).*

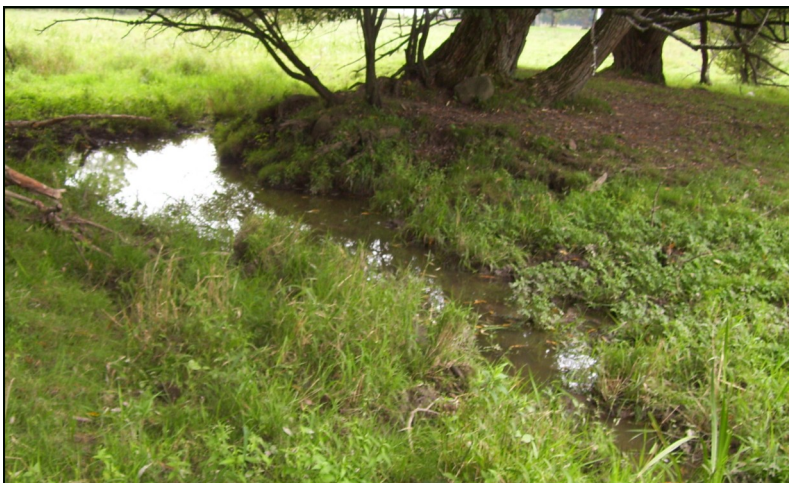
**October 18, 2011: Town of Locke**— OLWIP was notified of cows dwelling in a tributary which outlets directly to the Owasco Inlet. OLWIP contacted the farmer who proceeded to explain his plans to install fencing around either bank of the tributary. OLWIP has been working closely with CCSWCD to request grant funds to aid the farmer in the installment of fencing and an alternative water source for his cattle. The farmer also mentioned that he plans to reduce his herd by the Spring of 2012, bringing the head count to 10 cattle thus reducing his impact on the watershed even further.

*When livestock is allowed access to a tributary, it is common to see a degradation in the quality of the water and in the overall quality/appearance of the stream itself (left)*

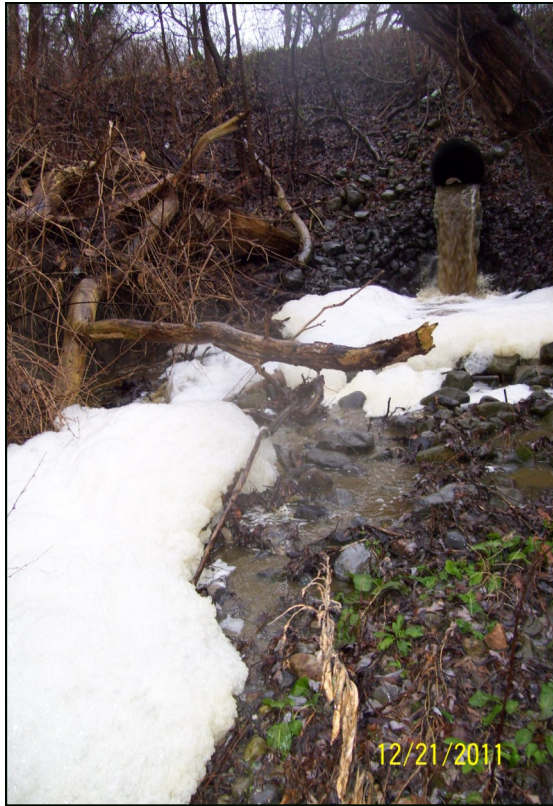
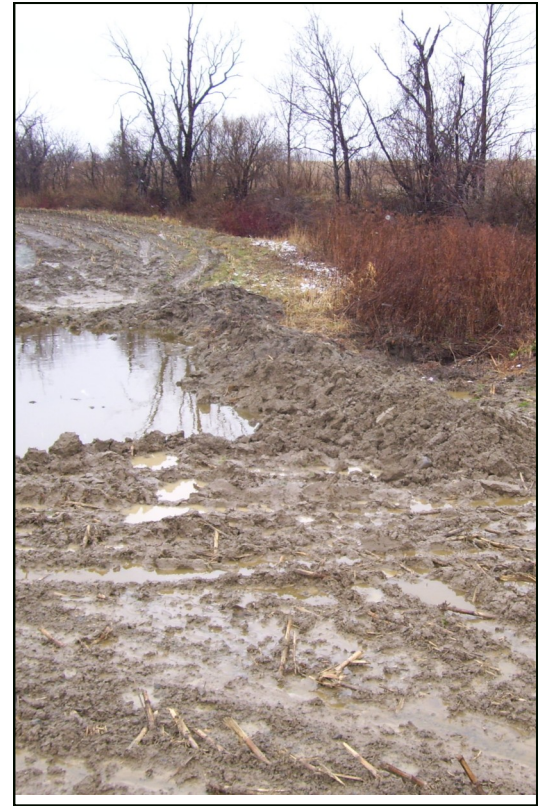
**December 21, 2011: Town of Skaneateles**—Manure runoff during a heavy rain event was reported to have been the cause of large amounts of foam collecting in a tributary to Dutch Hollow Brook. The foam was traced back to a source field situated on the watershed boundary between the Owasco Lake and Skaneateles Lake Watersheds. NYS DEC was contacted as well as the SLWAP and the SLWIP. OLVIP worked closely with the agencies involved to monitor remediation and cleanup. The farmer's NMP does not require him to till in the manure after spreading on that particular field. A revision request for the plan is currently taking place.

*Manure spread on a field leads to foaming due to an excessive amount of nutrients entering from runoff during a rain event (above left). A berm is installed where the grassed drainage swale empties into the tributary in order to catch runoff, allowing for any nutrients to settle before proceeding (above right).*

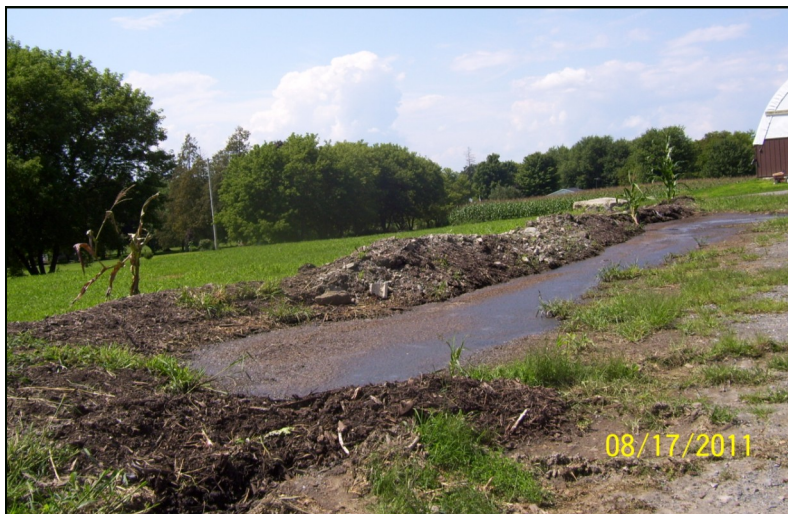
*A berm catches silage leachate before it reaches a roadside ditch (above).*

**September 24, 2010: Town of Owasco**— Original violation was filed by the NYS DEC after silage leachate was found flowing into a roadside ditch. NYS DEC then contacted the OLVIP and CCSWCD to formulate a plan to deal with the situation. CCSWCD and OLVIP suggested a revision to the farm's current NMP. Implementation of these revisions was not completed until the following summer.

**August 17, 2011**— Silage leachate was flowing into a roadside ditch after breaching a berm behind which the leachate was collected. A berm constructed from piles of wood mulch and concrete barriers were temporarily placed at the bottom of the driveway to contain the leachate. An NMP was drawn up by CCSWCD and is currently in the process of being implemented. OLVIP and CCSWCD have been monitoring the implementation.

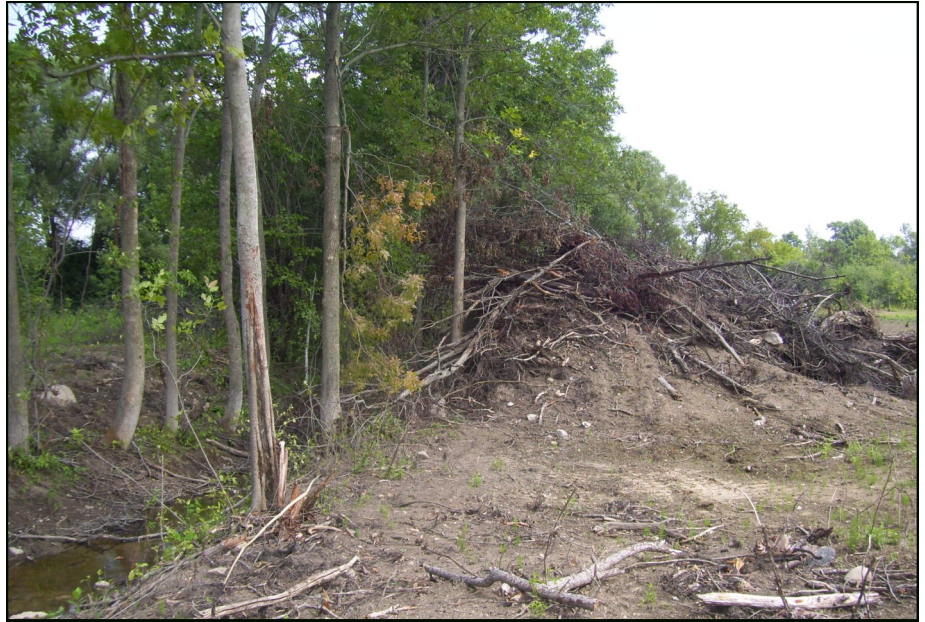
**July 29, 2011 Town of Fleming** - OLWIP responded to a complaint of major land clearing taking place in the town of Fleming. About 30 acres of land appeared to have been bulldozed to bare soil. All branches, woody vegetation, and other debris were pushed into large piles and set alongside the banks of the two tributaries that run through the property. Three land bridges appeared to have been constructed by pushing dirt directly into the north branch of the stream obstructing any potential flow. Silt fences were placed downstream of 2 of the land bridges and were installed perpendicular to the stream. There was one other land bridge installed on the south branch of the stream. NYS DEC has taken over a majority of the investigation. Work has been postponed until the spring season arrives. OLWIP worked with CCSWCD to establish a 25 foot stream buffer of winter wheat to stabilize the soil during the winter months.

*The above photo shows a large pile of dirt and debris that had been bulldozed right up to the edge of the stream bank. Situations like this increase the potential for runoff and sedimentation to occur leading to a degradation of water quality.*

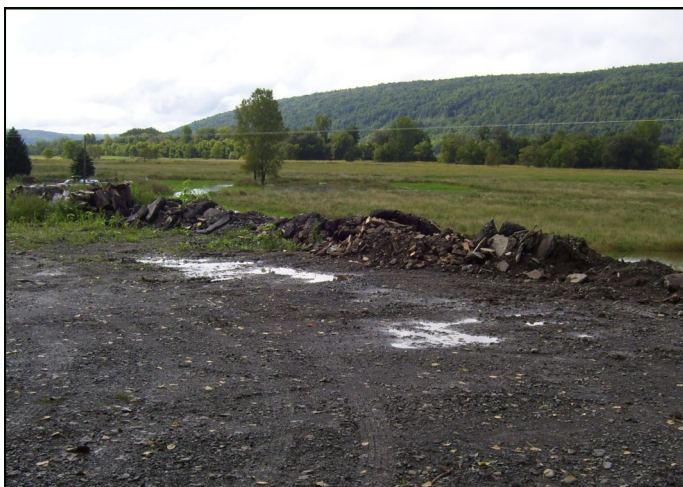
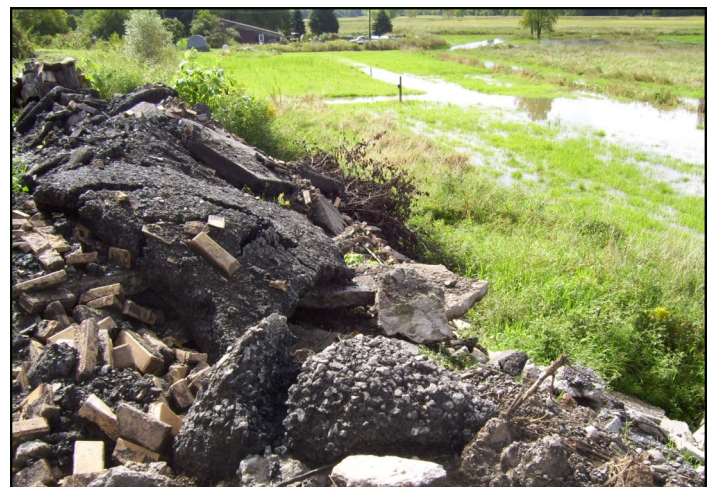
**September 8, 2011: Town of Moravia** – The USFWS contacted OLWIP requesting an inspection of a dump site located in Moravia. OLWIP visited the site where an assortment of materials were being dumped, prior to being bulldozed (lower left) The dumpsite, which is encroaching on a FEMA flood zone, consisted of materials such as crushed stone, boulders, concrete, asphalt, and woody debris (lower right). The USFWS has since taken over the investigation.

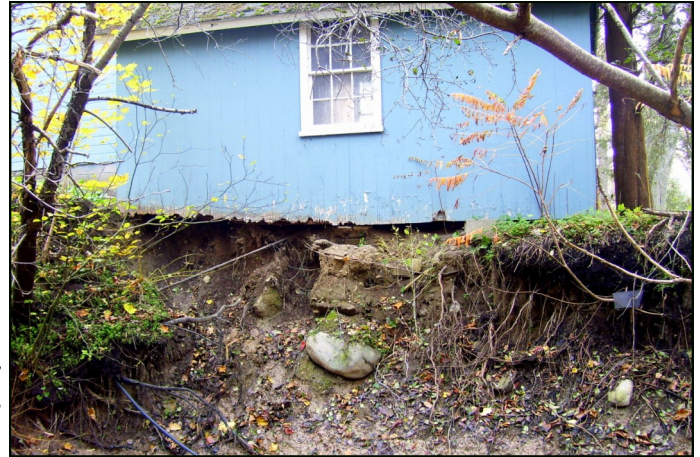
**October 31, 2011: Town of Owasco** – OLWIP received a call from a homeowner concerning the undermining of a small shed situated directly atop an eroding stream bank. OLWIP visited the site and worked with the homeowner to formulate several practical solutions regarding the issue. CCSWCD also provided insight, offering several other options to determine a low cost and effective solution.

The photo to the right demonstrates how the bank is undermining the shed sitting directly above. As high flow due to heavy rain events gush through a stream corridor, it carries with it sediment from the banks of the stream sometimes resulting in severe erosion.

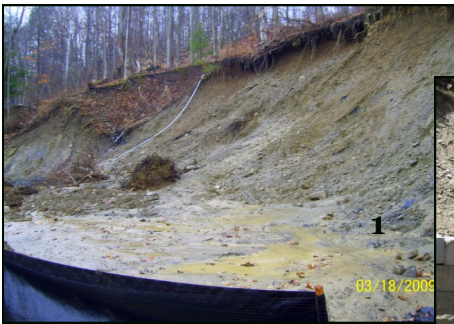
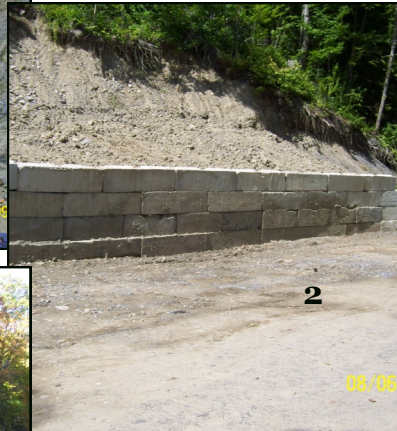
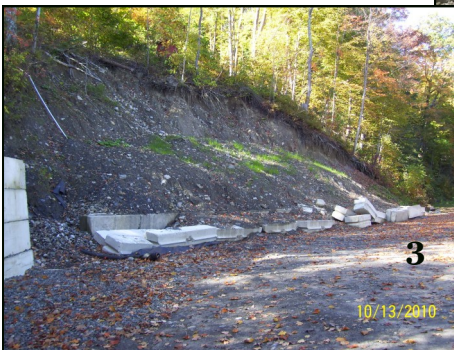
**Town of Scipio-** Since 2009, this site has been experiencing a significant portion of its bank lost due to massive erosion and undersized stormwater practices (photo 1). In 2010 OLWIP worked with CCSWCD to establish the size of the property's sub-watershed and to determine the path of all drainageways.

Both agencies recommended the landowner hire a professional contractor, which they did, and later had a retaining wall installed (photo 2). The retaining wall later failed due to poor installation and ignoring upslope water concerns (photo 3). After not responding for several months, the landowner contacted OLWIP on December 27, 2011 to discuss the matter. It was mentioned that the contractor hired will be installing a new retention wall in the Spring of 2012. Although OLWIP had already forwarded all information to the NYS DEC at that time, the Program is willing to continue working with the landowner.

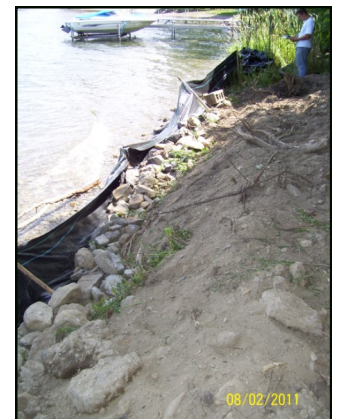
**Town of Scipio-** Lakefront construction of a house began in May 2009 and proceeded until July 2010. During that time, OLWIP worked with the homeowner to ensure all erosion and sediment control practices were installed and functioning properly. Seasonal inspectors completed a follow-up inspection on August 3, 2011 and found a silt fence was improperly installed at the base of an unstable bank that was located directly on the lakeshore (right). OLWIP worked with the homeowner to properly install the silt fence. The bank has since been seeded and stabilized.

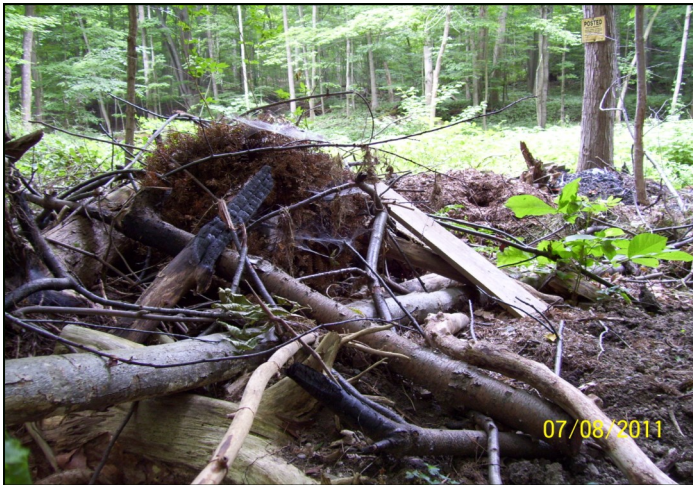
*Before:*

*July 8, 2011: Town of Moravia* - : During a feeder stream inspection, seasonal inspectors discovered an area of nearly half an acre where materials such as yard waste, ashes, scrap metal, dead fish, and other miscellaneous non-decomposables were being deposited directly on the bank of a stream. The site, located about 450 feet from the lakeshore, was owned by a homeowners association of which, OLWIP worked closely with to ensure removal of the materials. A follow-up inspection performed in November showed the site had been completely cleaned and all materials had been removed. A copy of the OLWRRs was sent to the homeowners association to ensure prevention of any violations in the future.

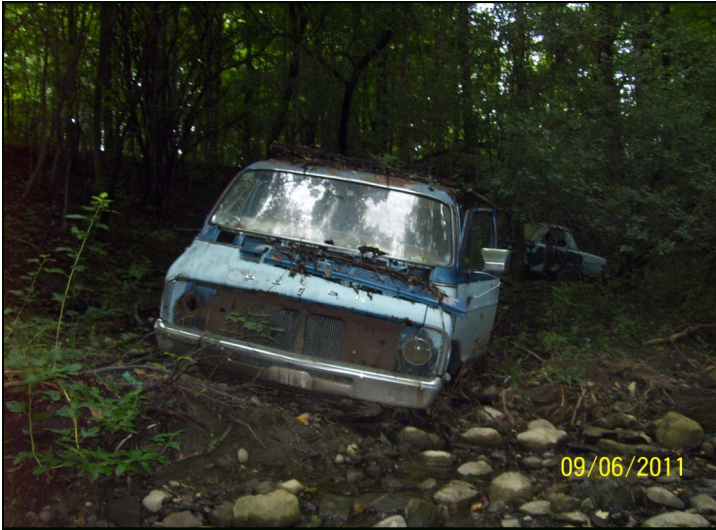
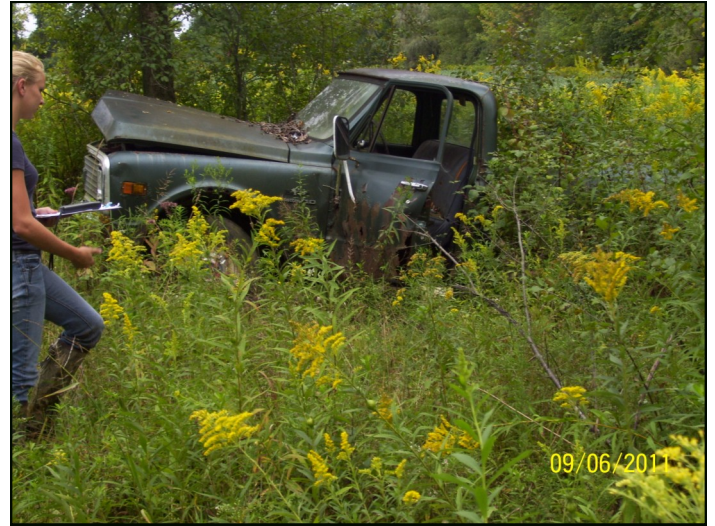
**September 6, 2011: Town of Owasco** – During a survey of one of the tributaries of Sucker Brook, seasonal inspectors came across 2 junk cars located directly in a stream corridor. After further inspection, several more junk cars were found situated within a 100 foot linear distance of the stream. Two violation notices have been sent to the landowner from both OLWIP and Owasco Code Enforcement. OLWIP has yet to hear back from the landowner and has sent CCHD all information regarding the situation. CCHD has assumed enforcement of the situation.

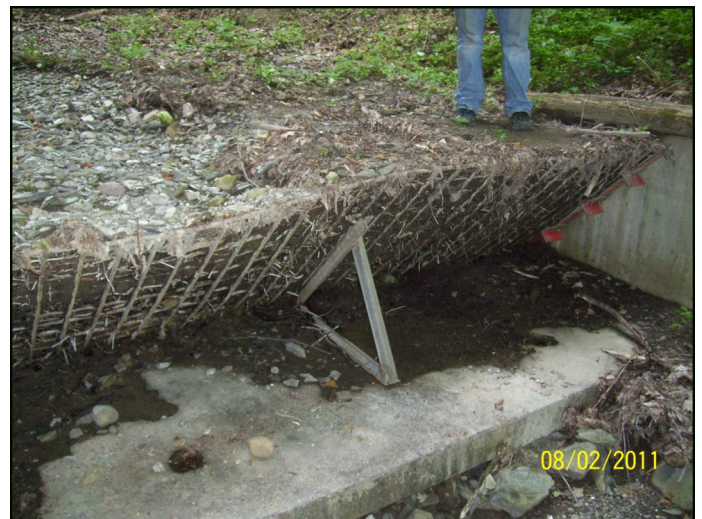
**July 31, 2009: Town of Scipio** – The trash grate installed by CCSWCD in the past has since become so overwhelmed with dirt and debris that it is no longer effective. The grate is the responsibility of the homeowner’s association on which land it resides, therefore they assume the task of maintaining it. A follow up inspection of the grate was performed this past summer, however, it has not been cleaned out since the inspection program initially noted the situation in 2009.

*Assistant watershed inspector Sandro Valle stands atop the filled-in trash grate*

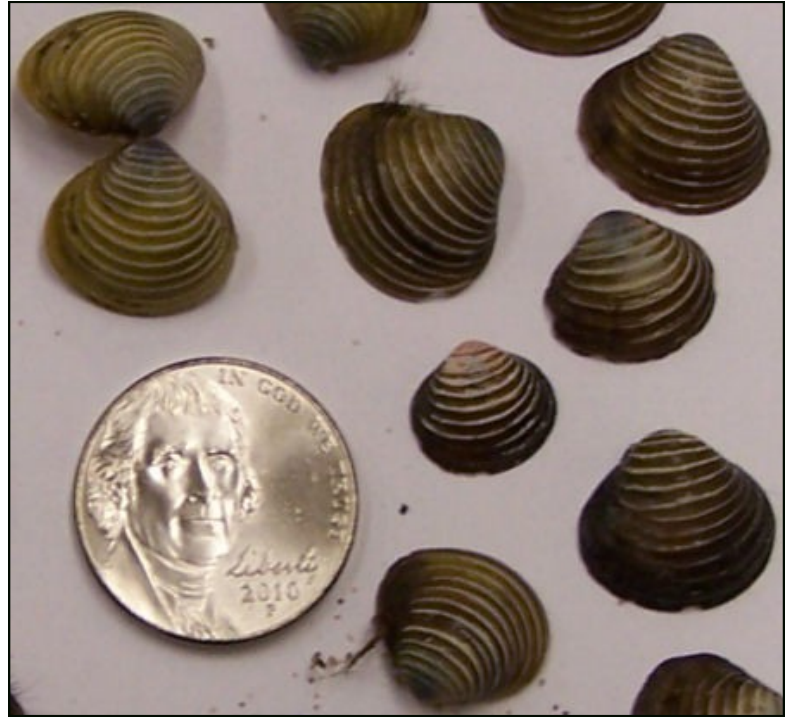
*The above photo demonstrates the size and coloration of the Asian clam. They typically take on a yellow brown or light brown to black color with distinctive elevated, evenly spaced ridges on the surface and average the size of a dime or nickel.*

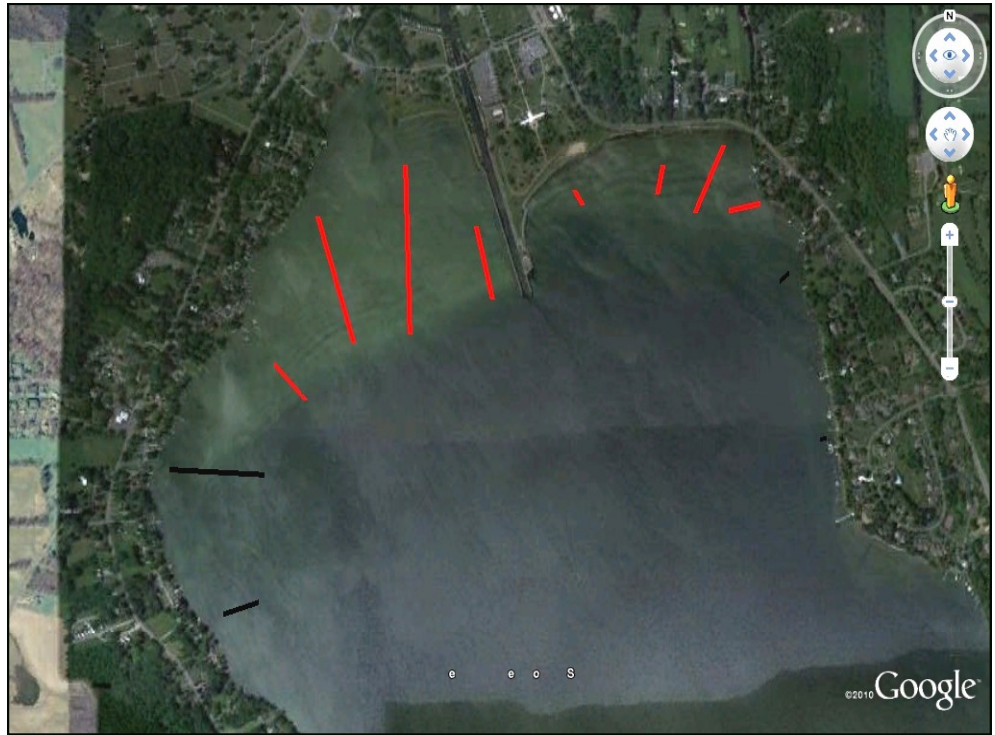
Living Asian clams were located at the northern end of Owasco Lake in shallow water of depths ranging from 3 to 6 feet. One location to the west of the Owasco Lake outlet was recorded to be approximately 8 feet deep, but all other Asian clam populations were limited to depths of less than 6 feet. Because of the conservative methods used to determine population distribution it is likely that the 8 foot depth is incorrect.

*The aerial photo above shows the study area where the survey took place. The lines shown demonstrate where all density surveys were performed and the red lines indicate where living Asian clams were found in the sediment.*

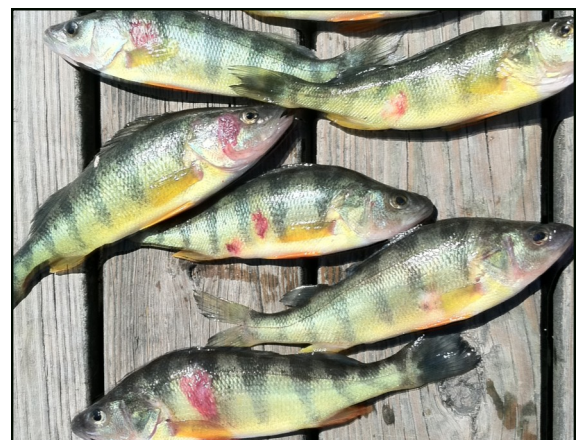
Also discovered during the survey were 12 yellow perch (from a catch of about 30) with red sores in various parts of their bodies. It was later confirmed that the ulcers were caused from "Red Sore Disease." Typically, red sore disease is caused by two organisms, *Aeromonas hydrophila*, a bacterium, and *Heteropolaria sp.* (formerly *Epistylis sp.*), a protozoan. Red sore disease will often run its course, and fish may recover without treatment. The disease is not dangerous to humans and fish caught with this condition are safe for human ingestion.

*Yellow perch infected with red sore disease.*

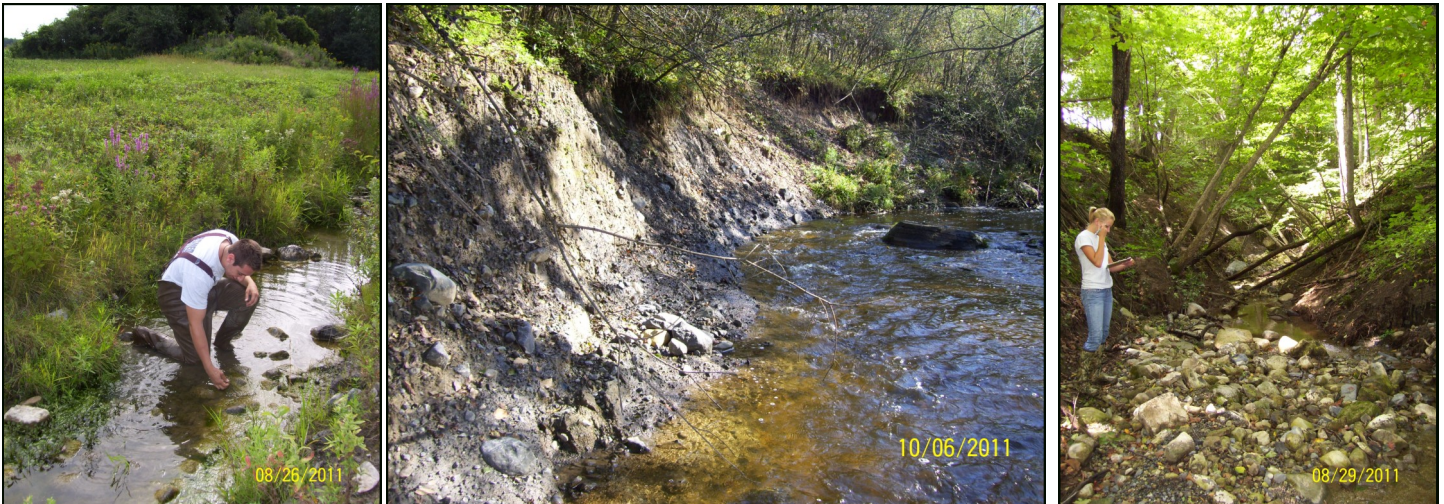
As an extension to the Sucker Brook Streambank Management Plan conducted in 2003, a basic survey of Sucker Brook and all of its tributaries was completed this summer by assistant watershed inspectors. During the survey, they collected data such as substrate types, flow regimes, bank conditions and other general properties of both in-stream and corridor characteristics. The purpose of this survey was to identify additional areas of concern throughout Sucker Brook and aid in its bank restoration to reduce sediment and nutrient loading into the lake.

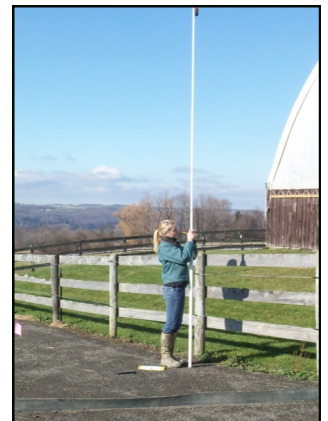
**Agriculture Environmental Management (AEM)** – The AEM program is a statewide agricultural program administered through each county's soil and water conservation district. AEM uses a tiered approach that assesses farms on a voluntary basis. Each farm analysis looks at the environmental impacts of the farm and compliments good practices that are already in place. From the compiled plan, solutions to water quality issues can be determined and improvements can be made. Since August 2011, OLWIP has worked on five different projects within the watershed that include AEM involvement. *Watershed inspector Katie Jakaub assists CCSWCD's Grazing Specialist Jason Cuddeback with an as-built survey (tier 4) on a horse farm within the watershed. (right).*
